Upper Salmon River Subbasin Assessment and TMDL

2016 Addendum and Five-Year Review

Hydrologic Unit Code 17060201

**State of Idaho
Department of Environmental Quality**

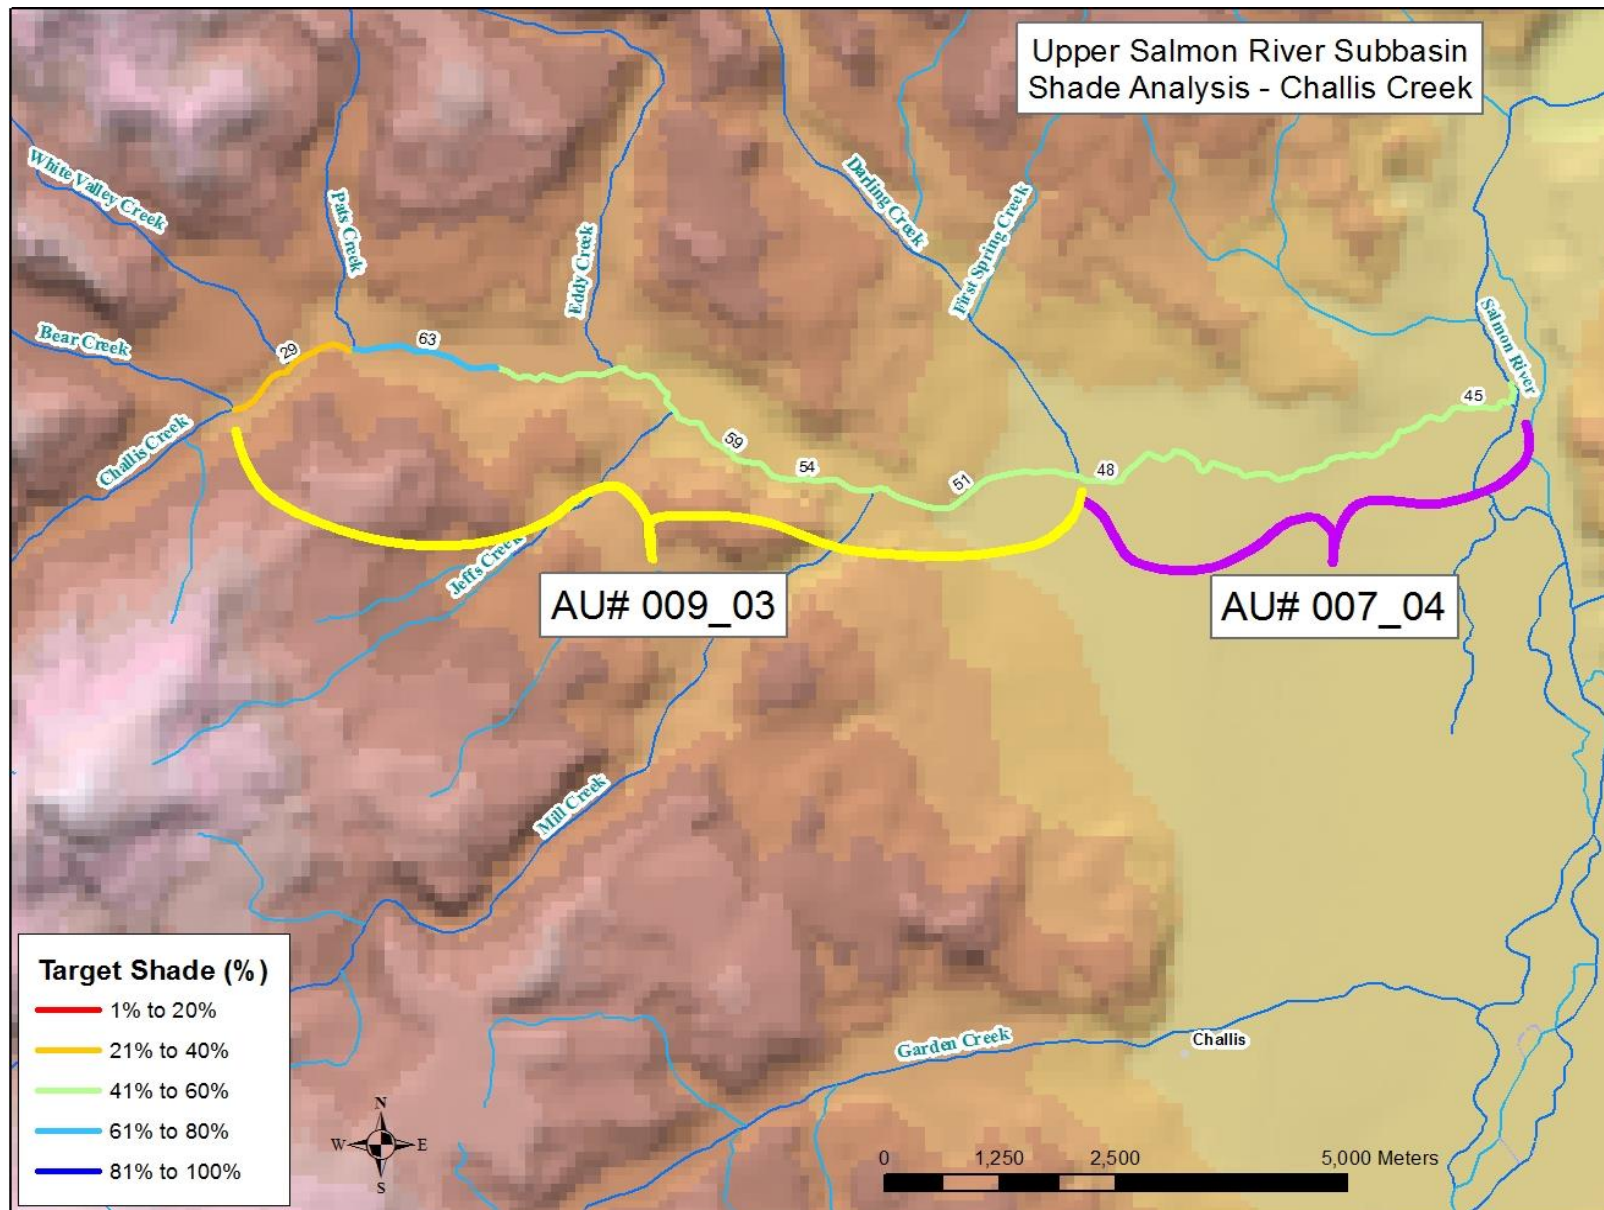
Figure H2. Target shade for Challis Creek.

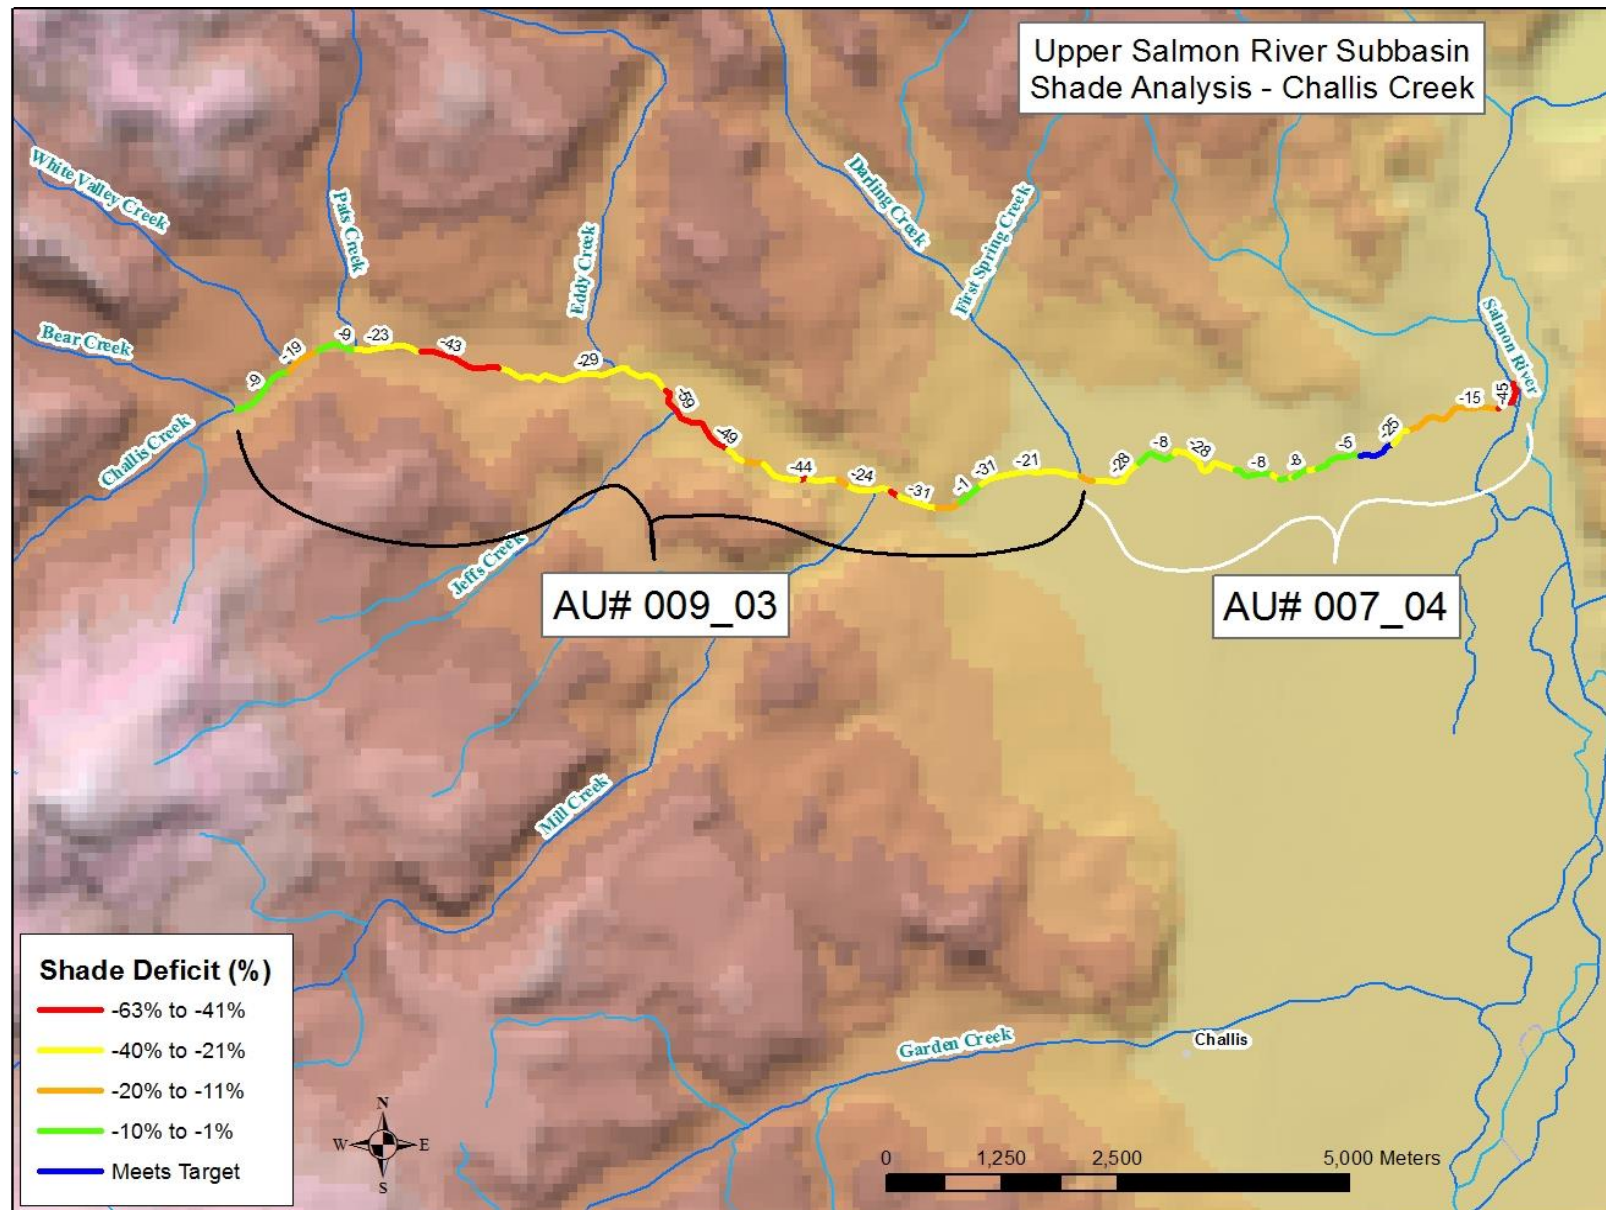
Figure H3. Lack of shade (difference between existing and target) for Challis Creek.

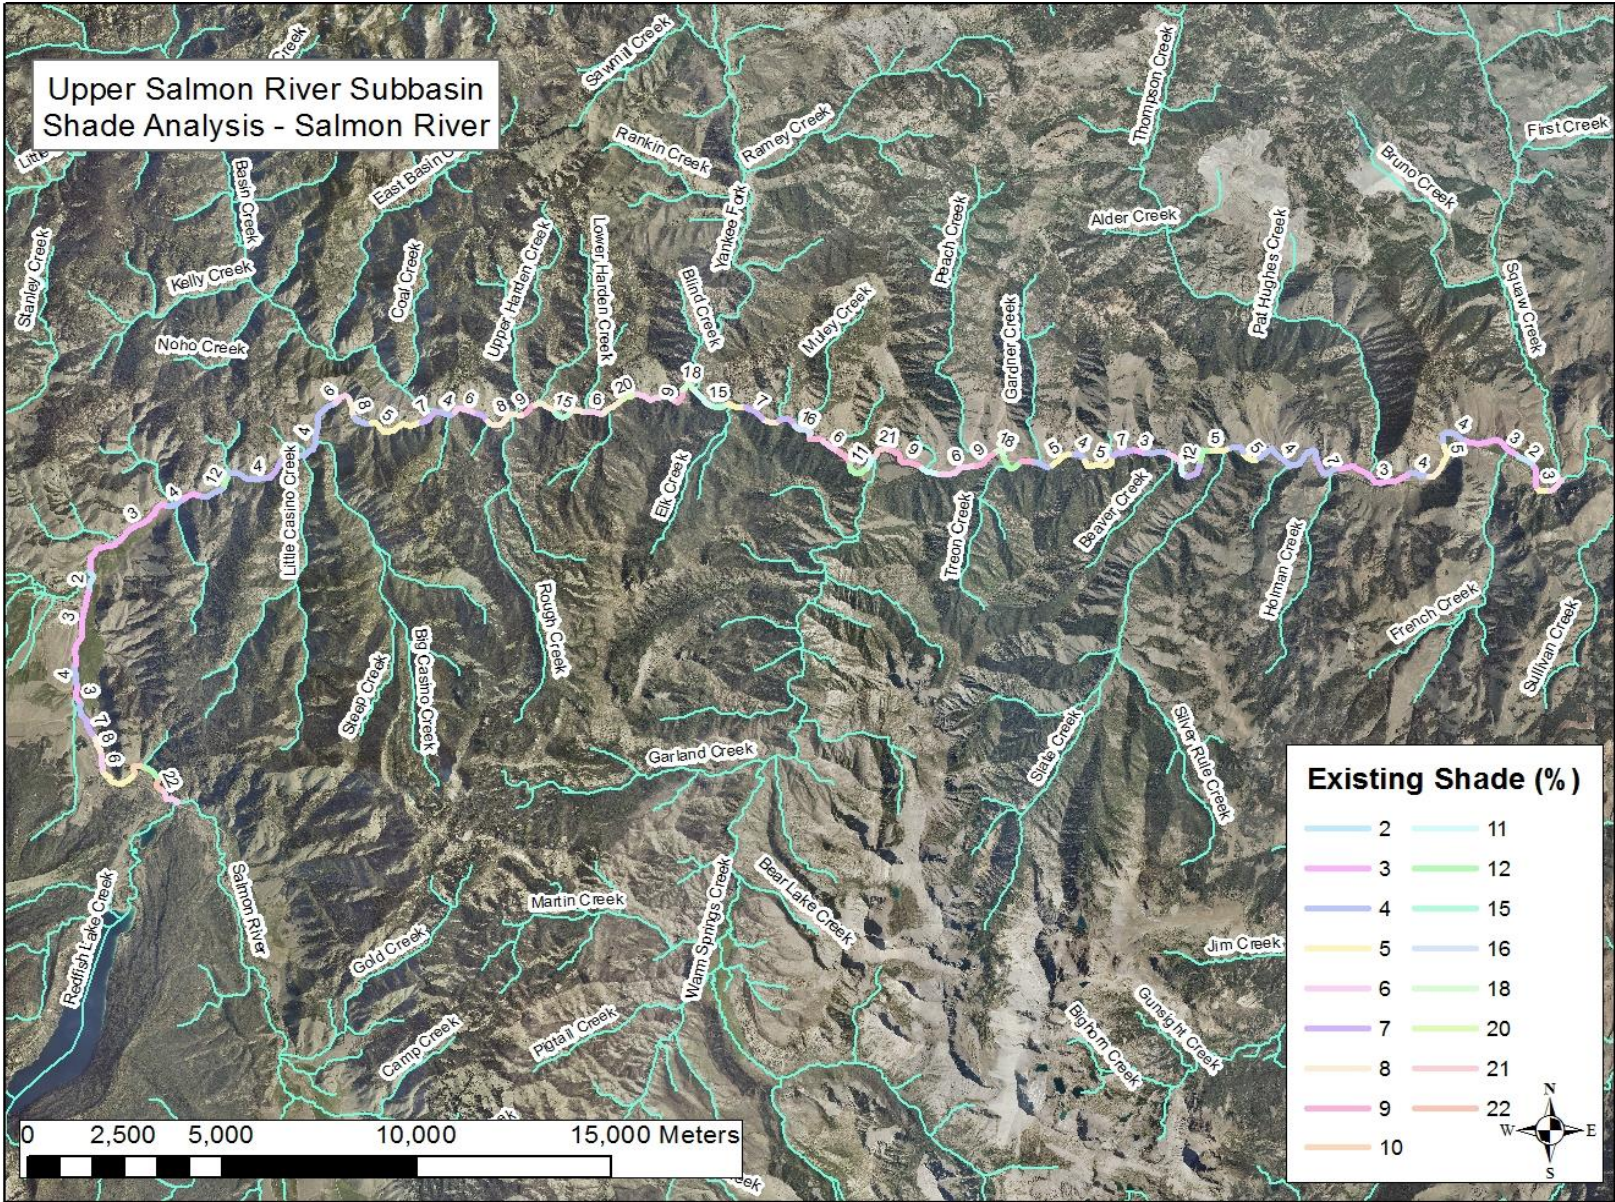
Figure H4. Existing shade estimated for the Salmon River by Heat Source modeling (shade-alator).

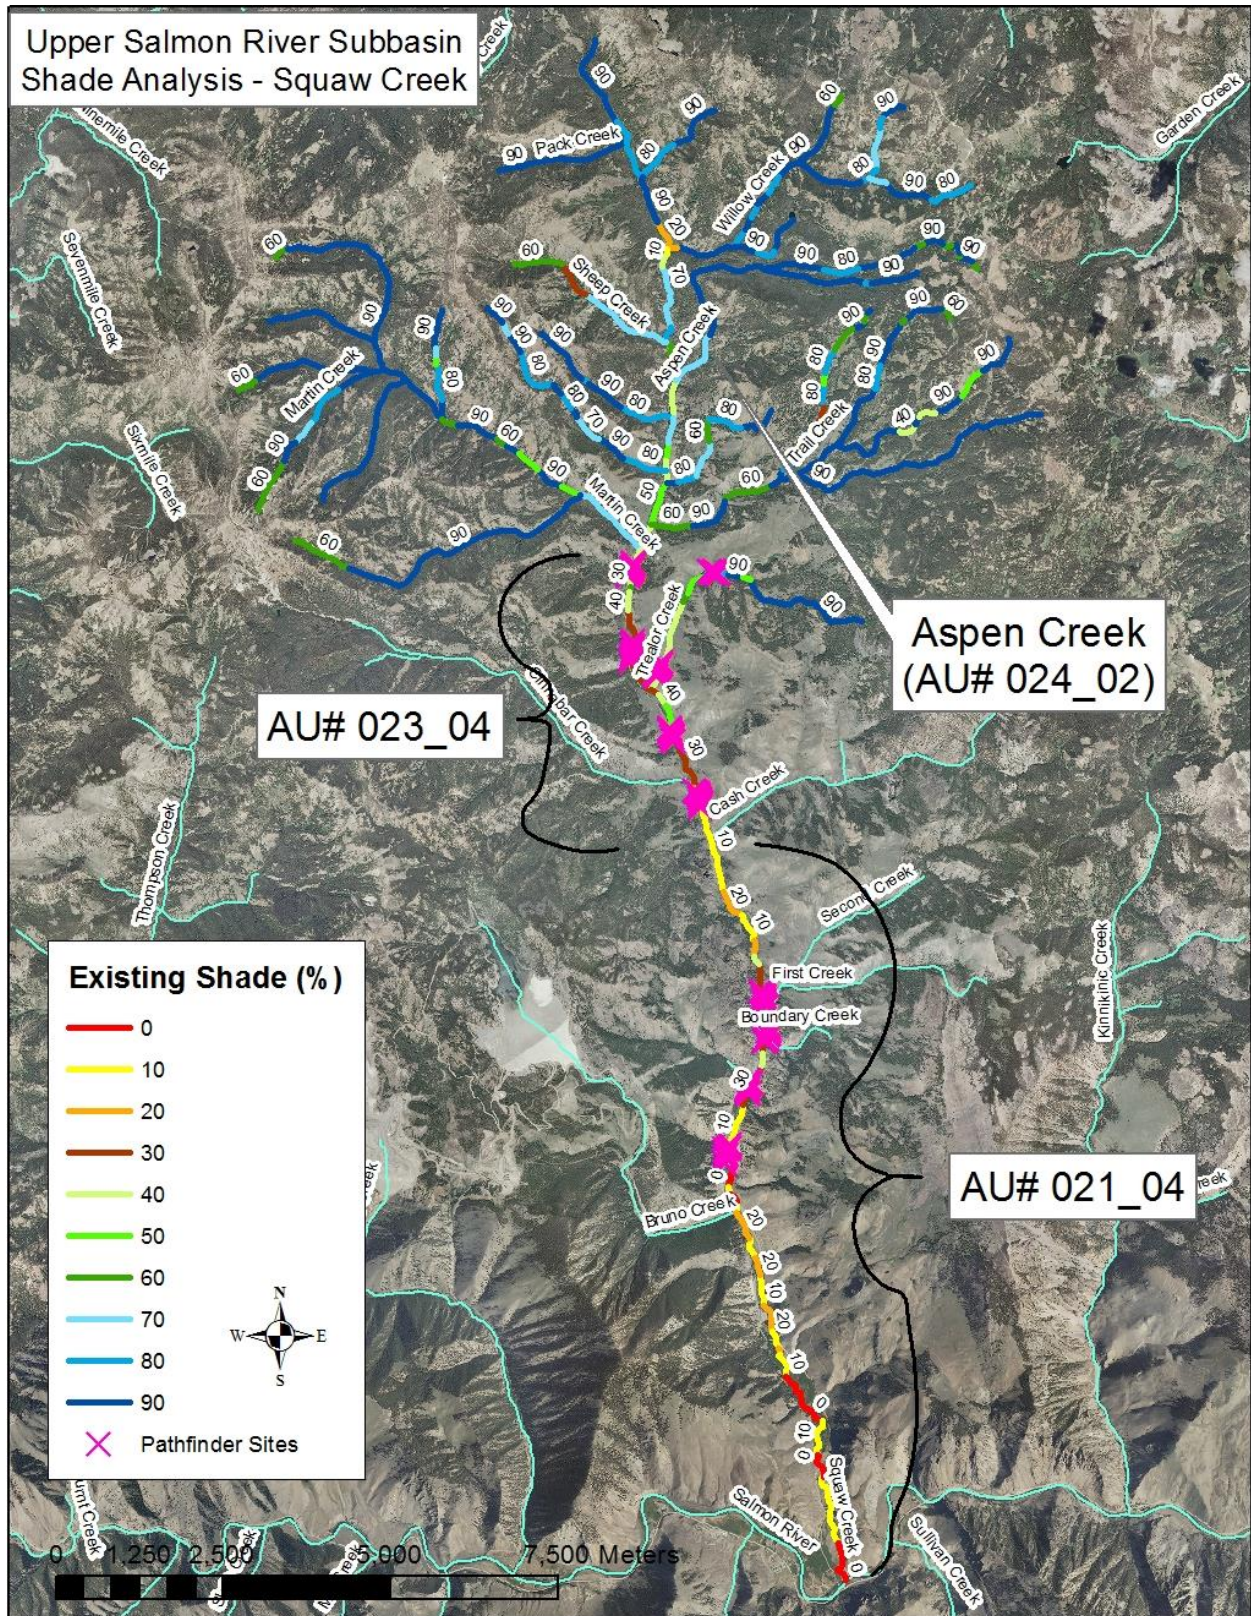
Figure H7. Existing shade estimated for Squaw Creek watershed by aerial photo interpretation.

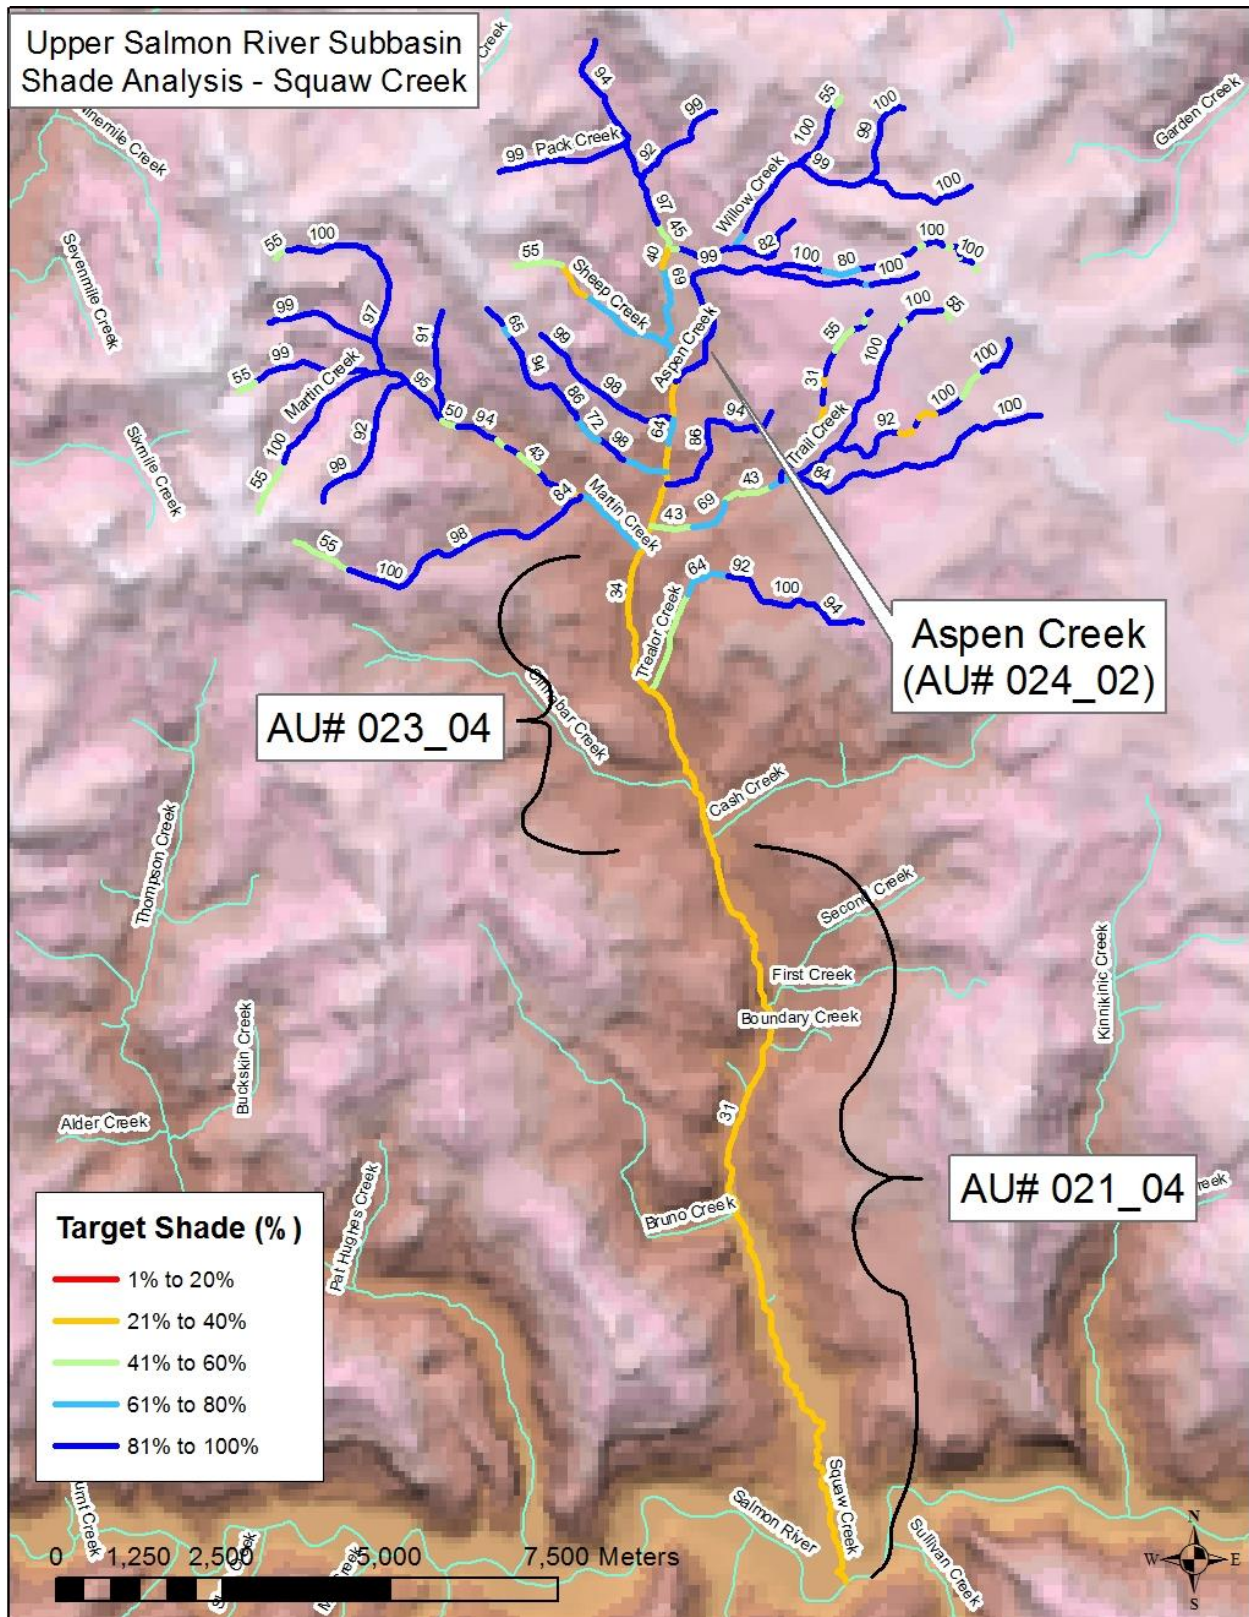
Figure H8. Target shade for Squaw Creek watershed.

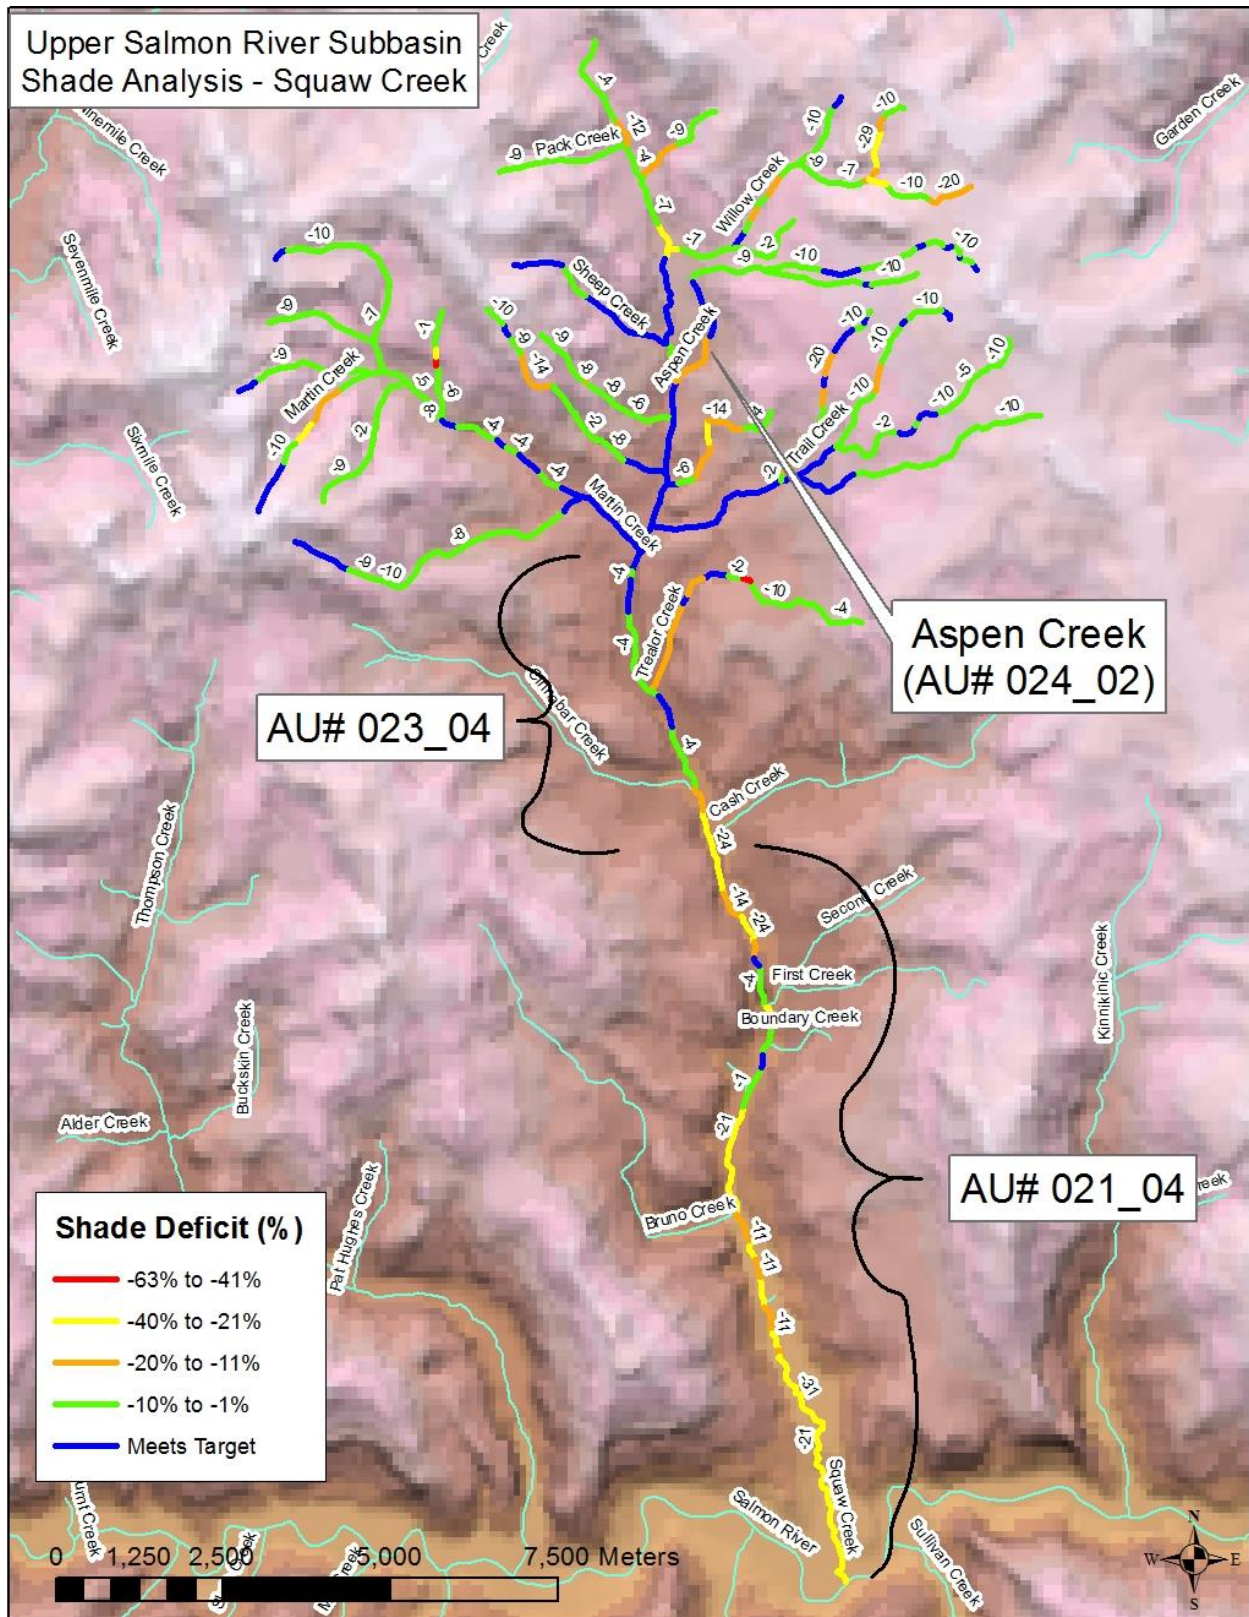
Figure H9. Lack of shade (difference between existing and target) for Squaw Creek watershed.

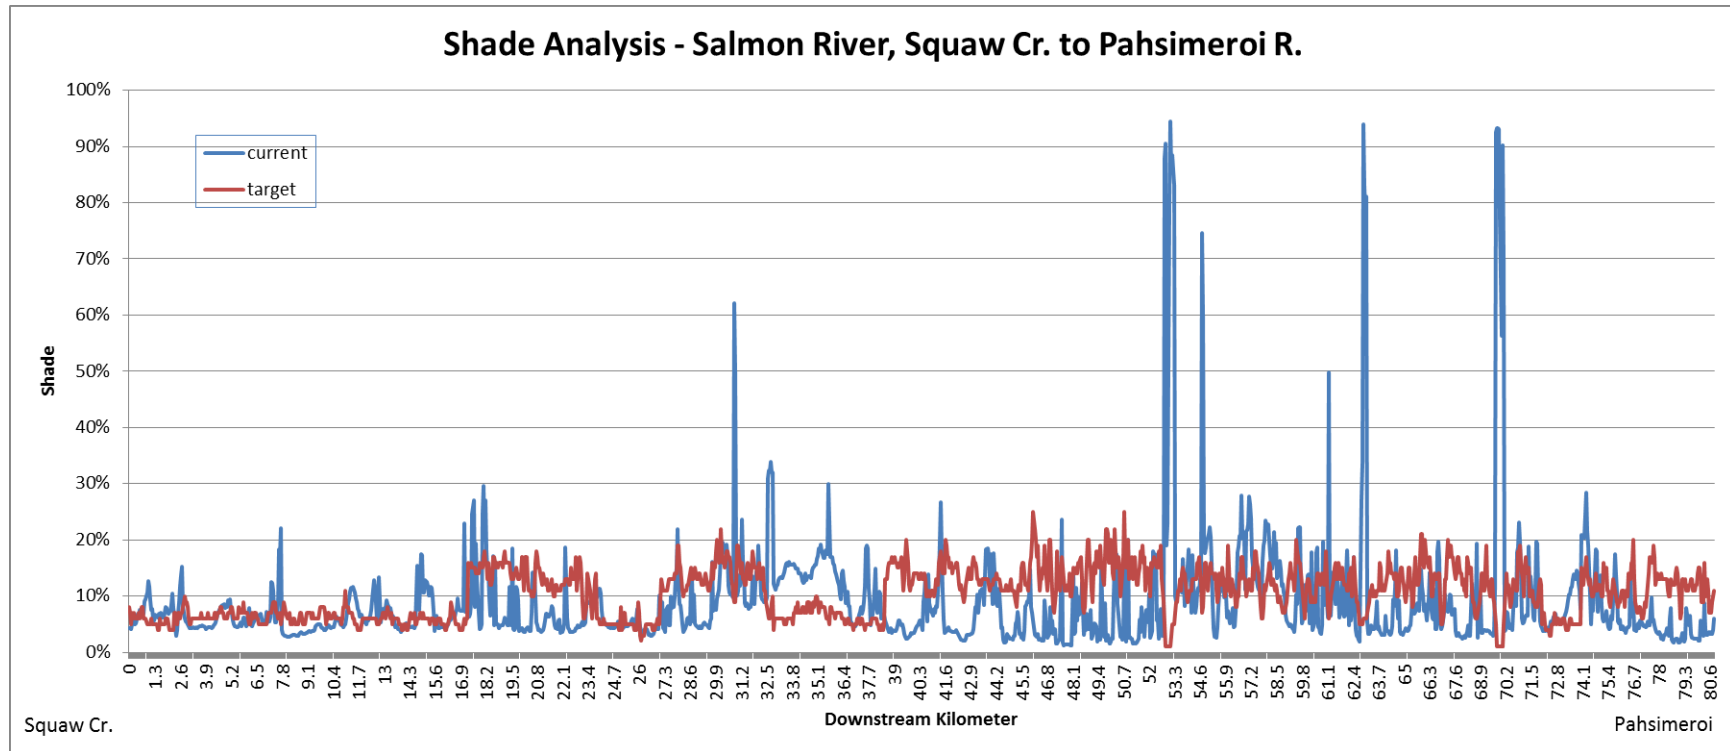
Figure H10. Existing shade estimated for Salmon River (Squaw Creek to Pahsimeroi River) by Heat Source modeling (shade-alator) and corresponding shade targets. Shade spikes are from vegetated islands.

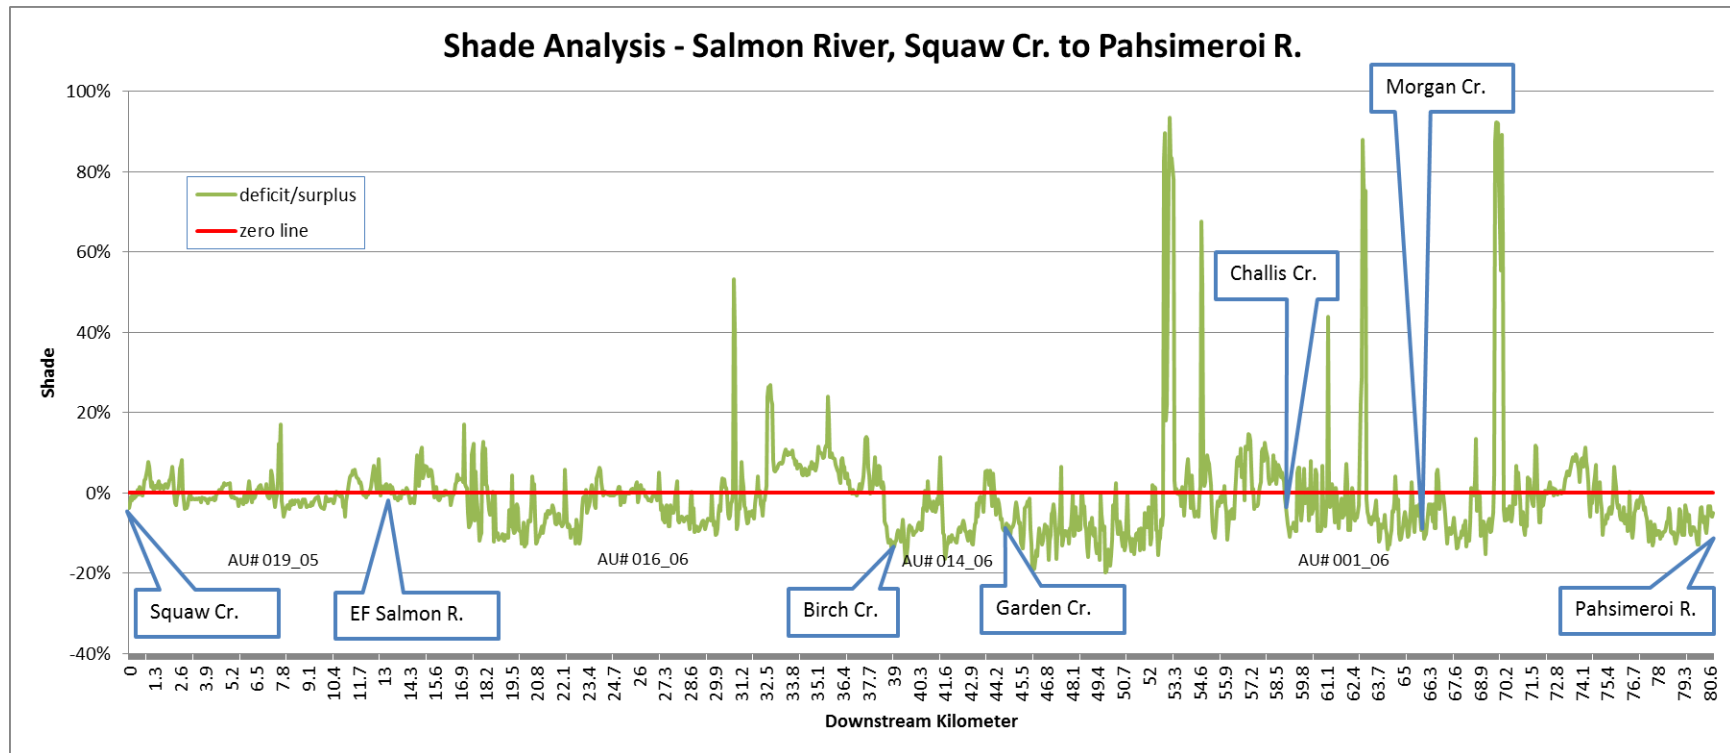
Figure H11. Differences between existing and target shade (also known as the deficit/surplus shade) for Salmon River, Squaw Creek to Pahsimeroi River. Creek names below the zero line are AU boundary locations.
